# TECHNICAL INSPECTION REPORT

U.S.S. PENSACOLA (CA24)

TEST ABLE

OPERATION CROSSROADS

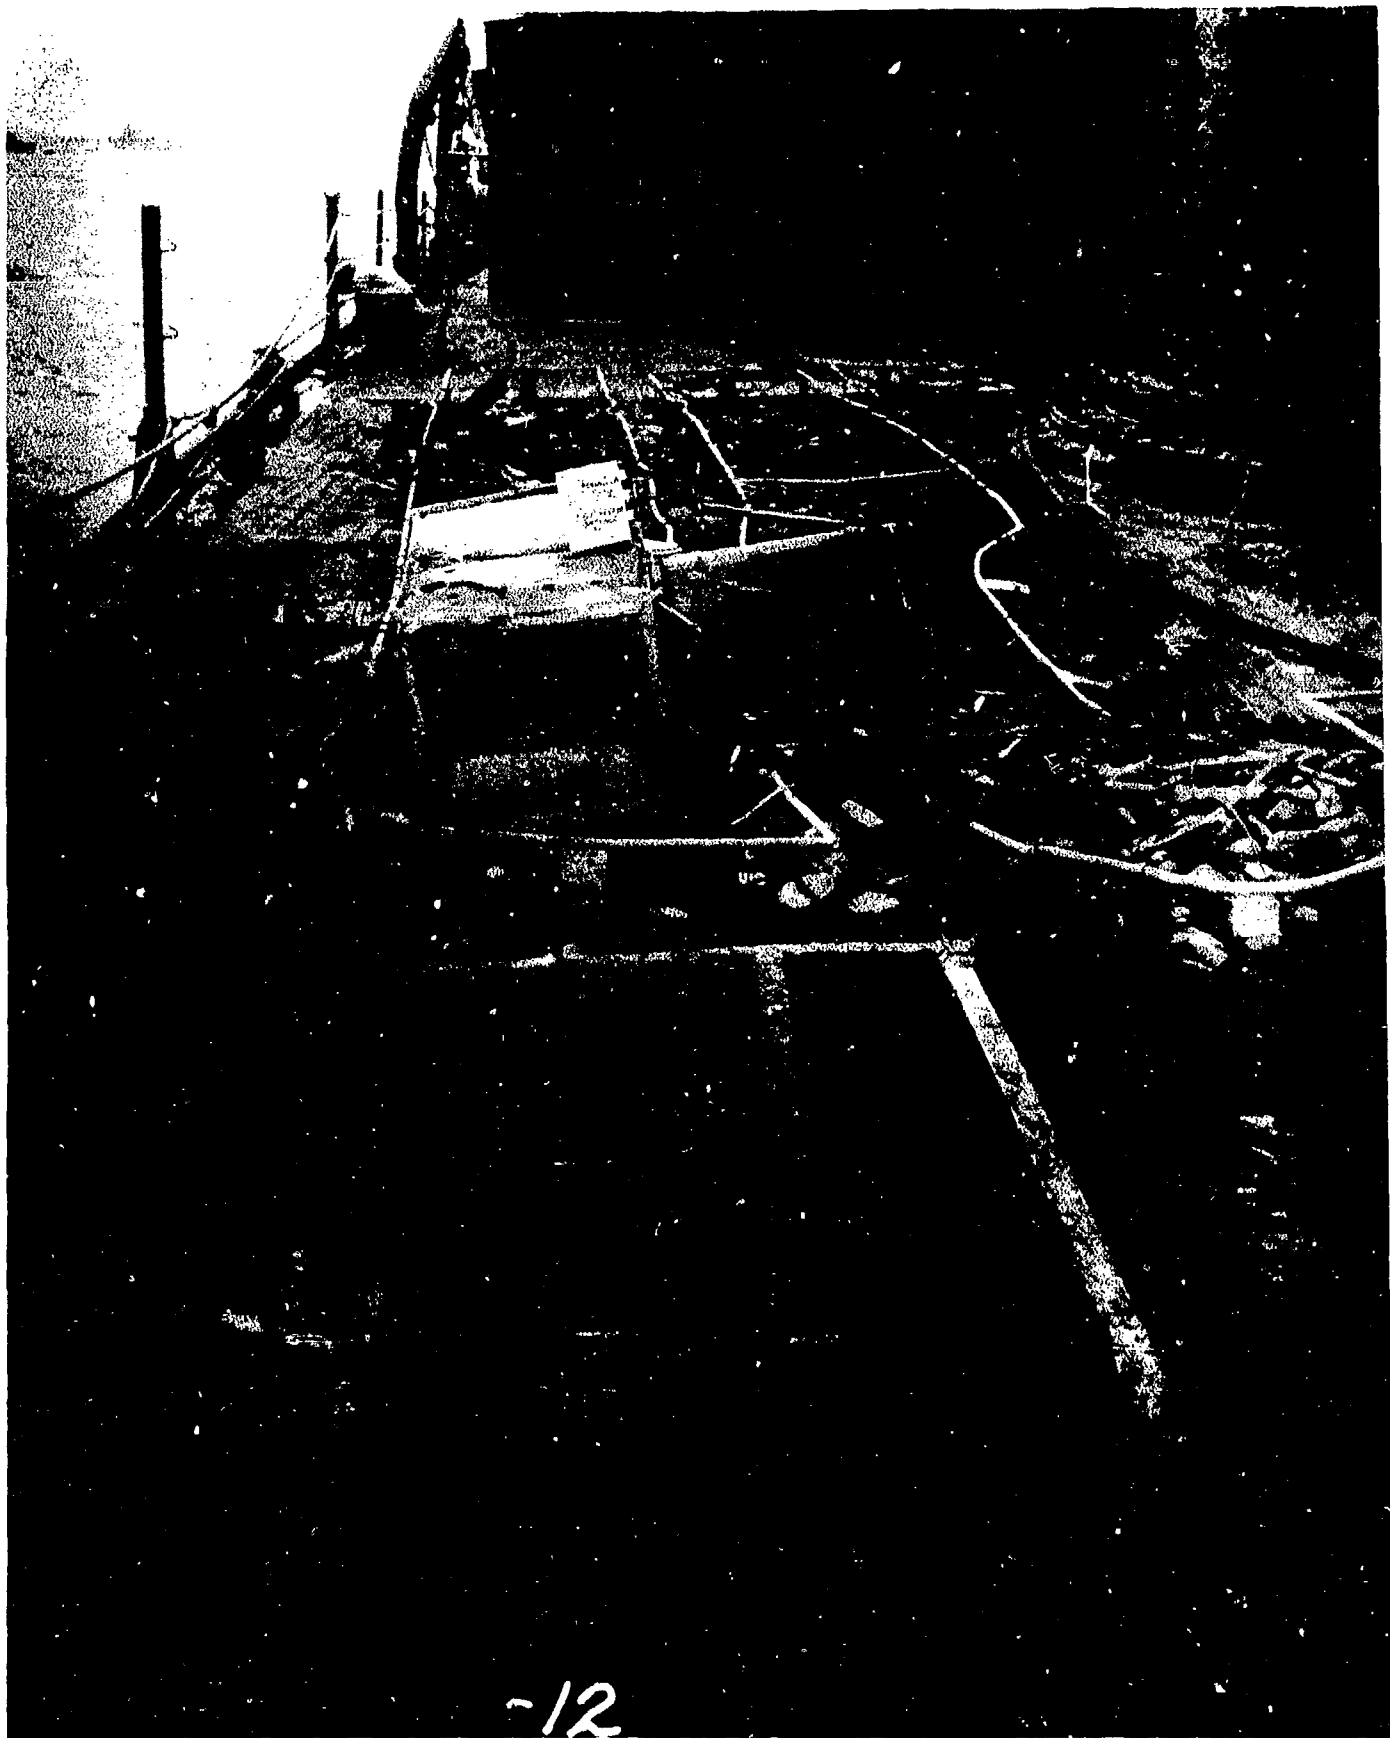
AA-CR-68-1756-12. Port side of weather deck, looking forward from frame 125 showing some of remains of burned Army equipment.

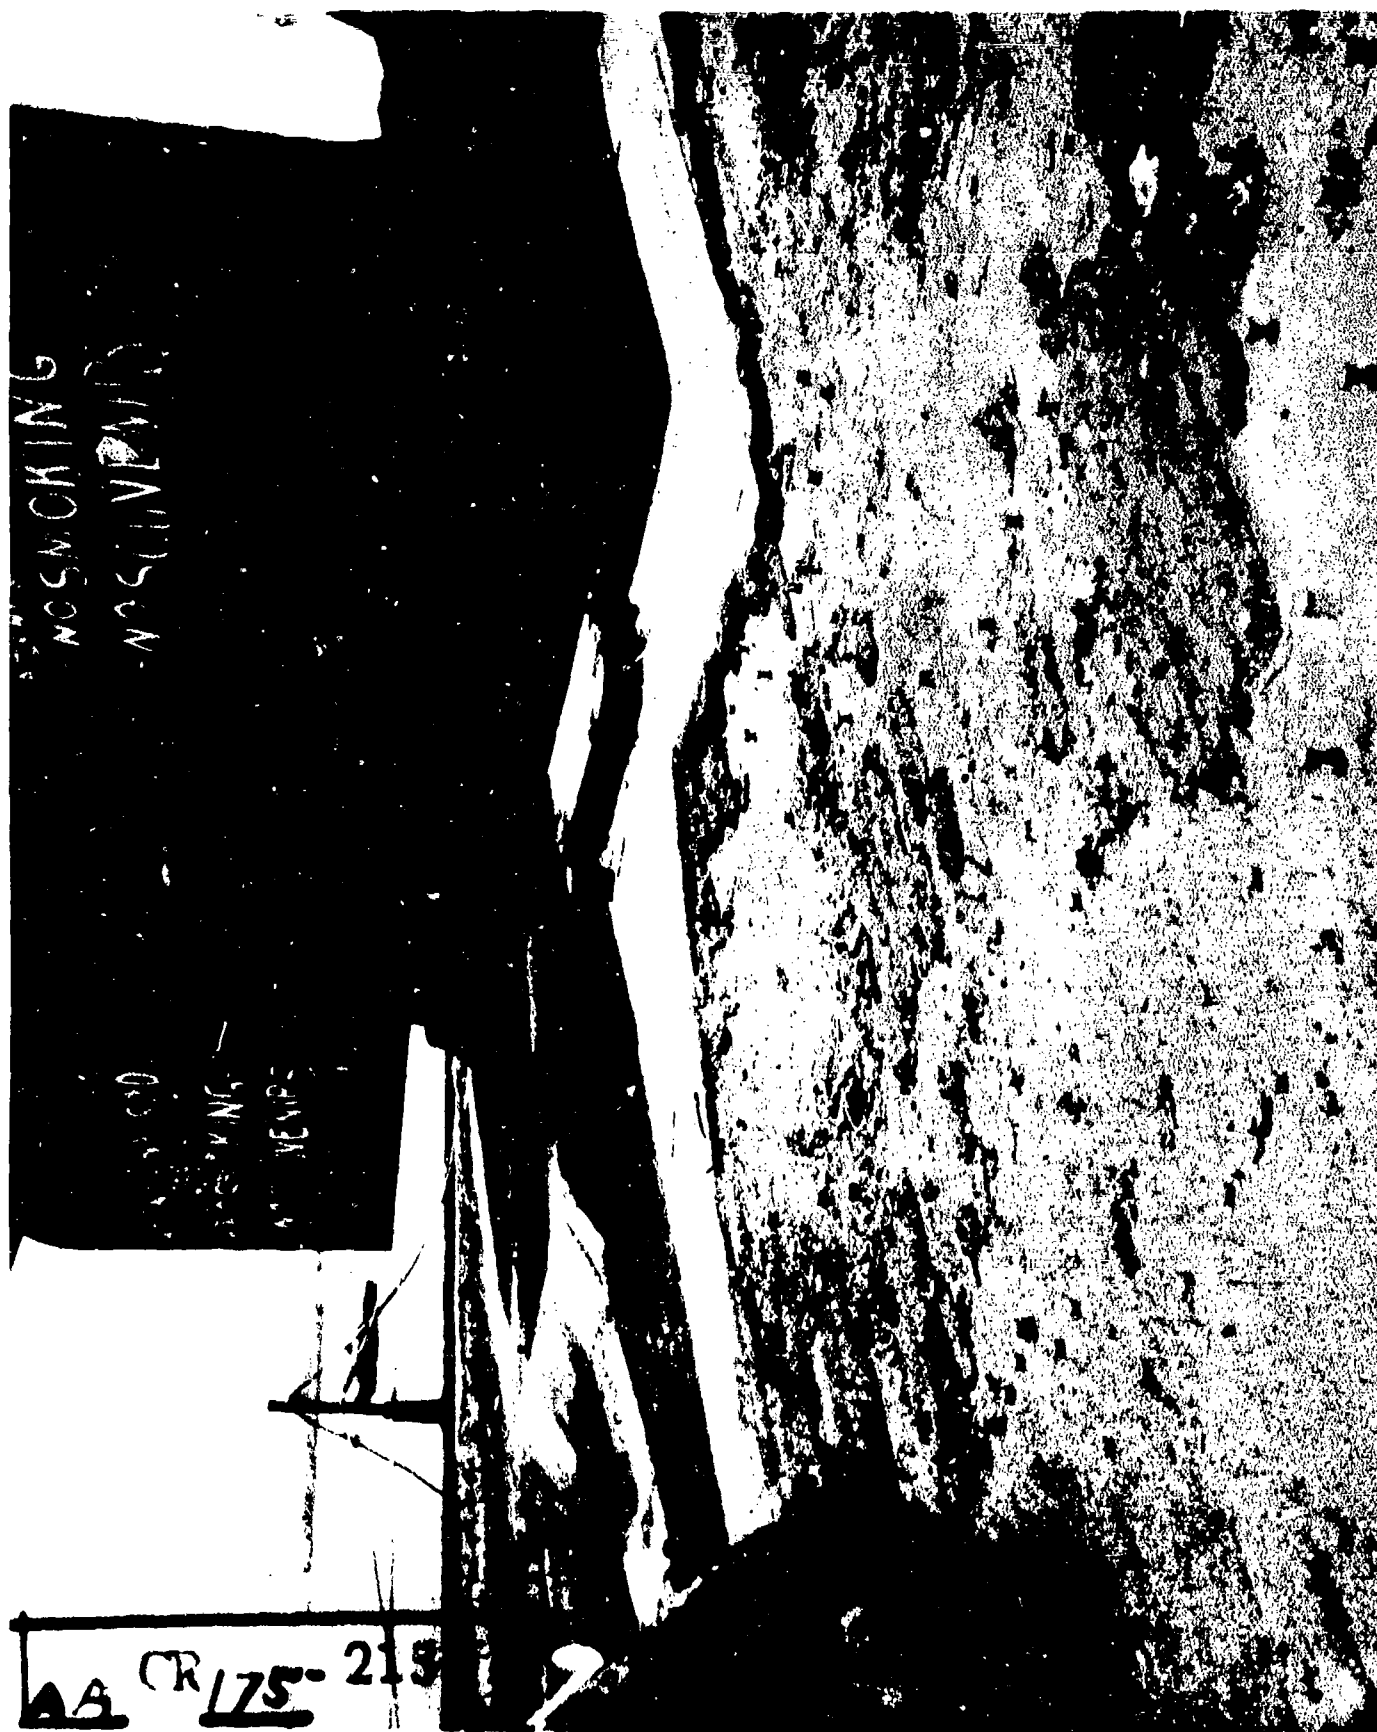
AA-CR-175-2158-9. Looking to port on main deck, frame 125, after burned Army equipment had been removed and the deck made watertight.

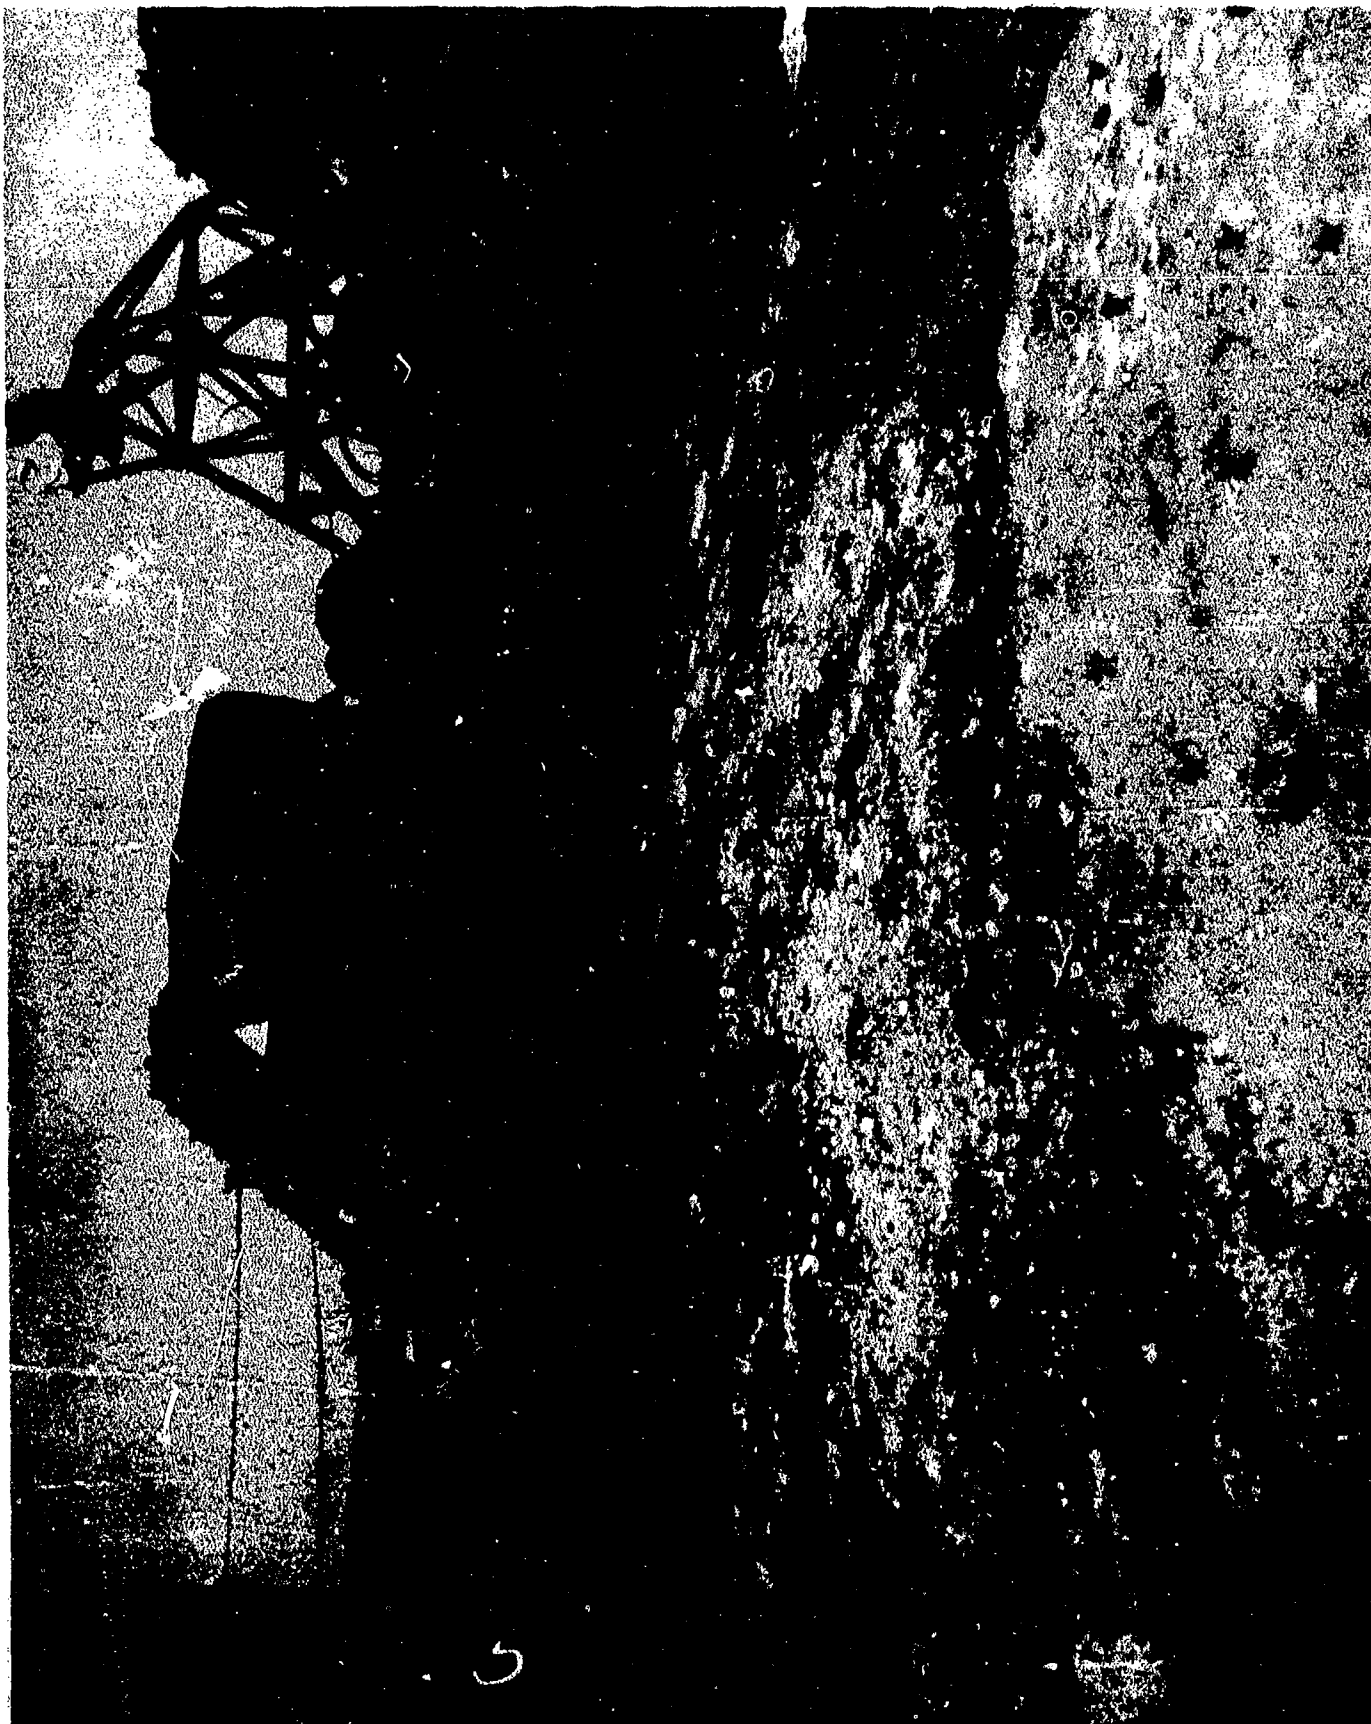
AA-CR-175-2158-5. Looking to starboard on weather deck, frame 122, after burned equipment stowed on deck during test, had been removed.

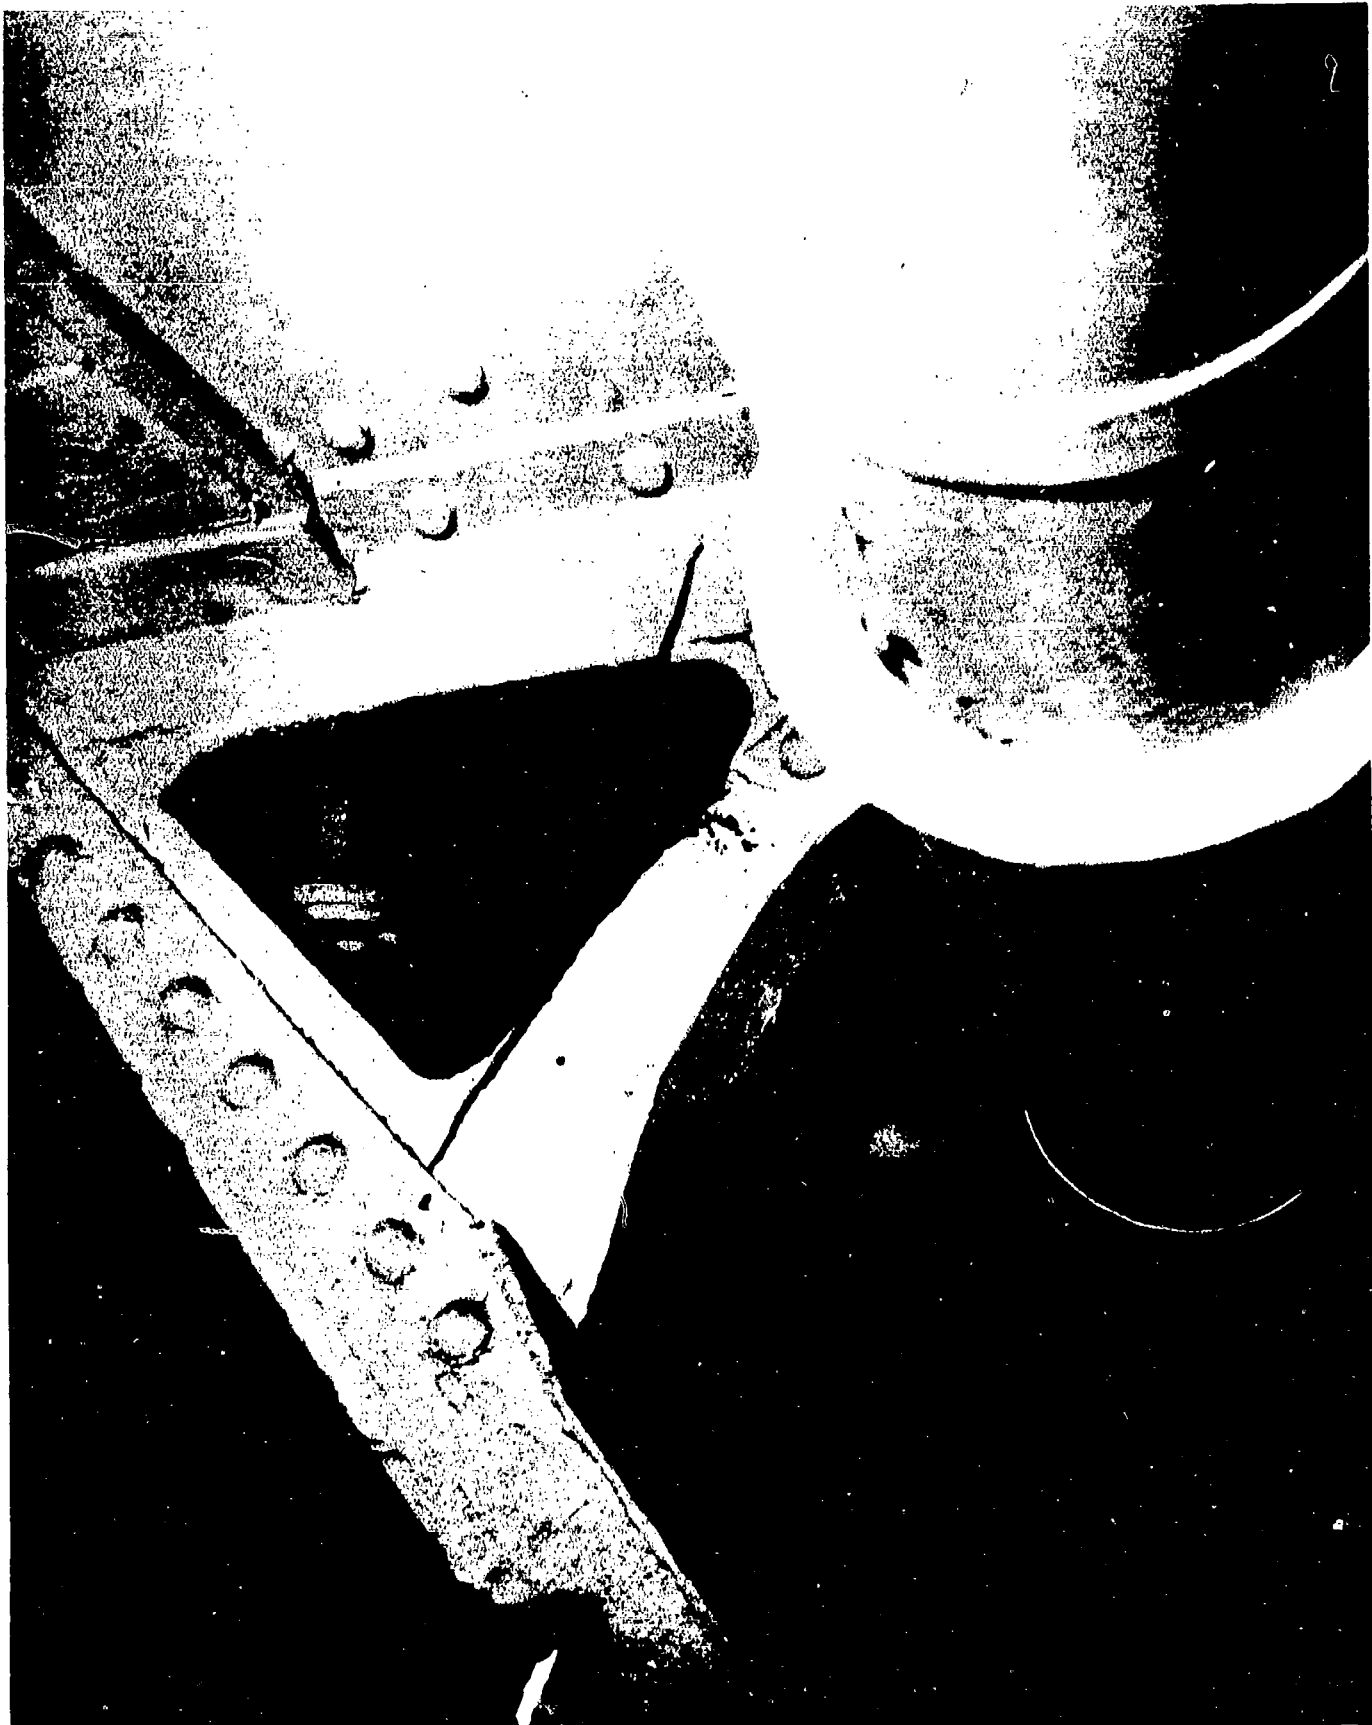
AA-CR-68-1762-1. Cracked bracket at frame 16 port side under main deck.

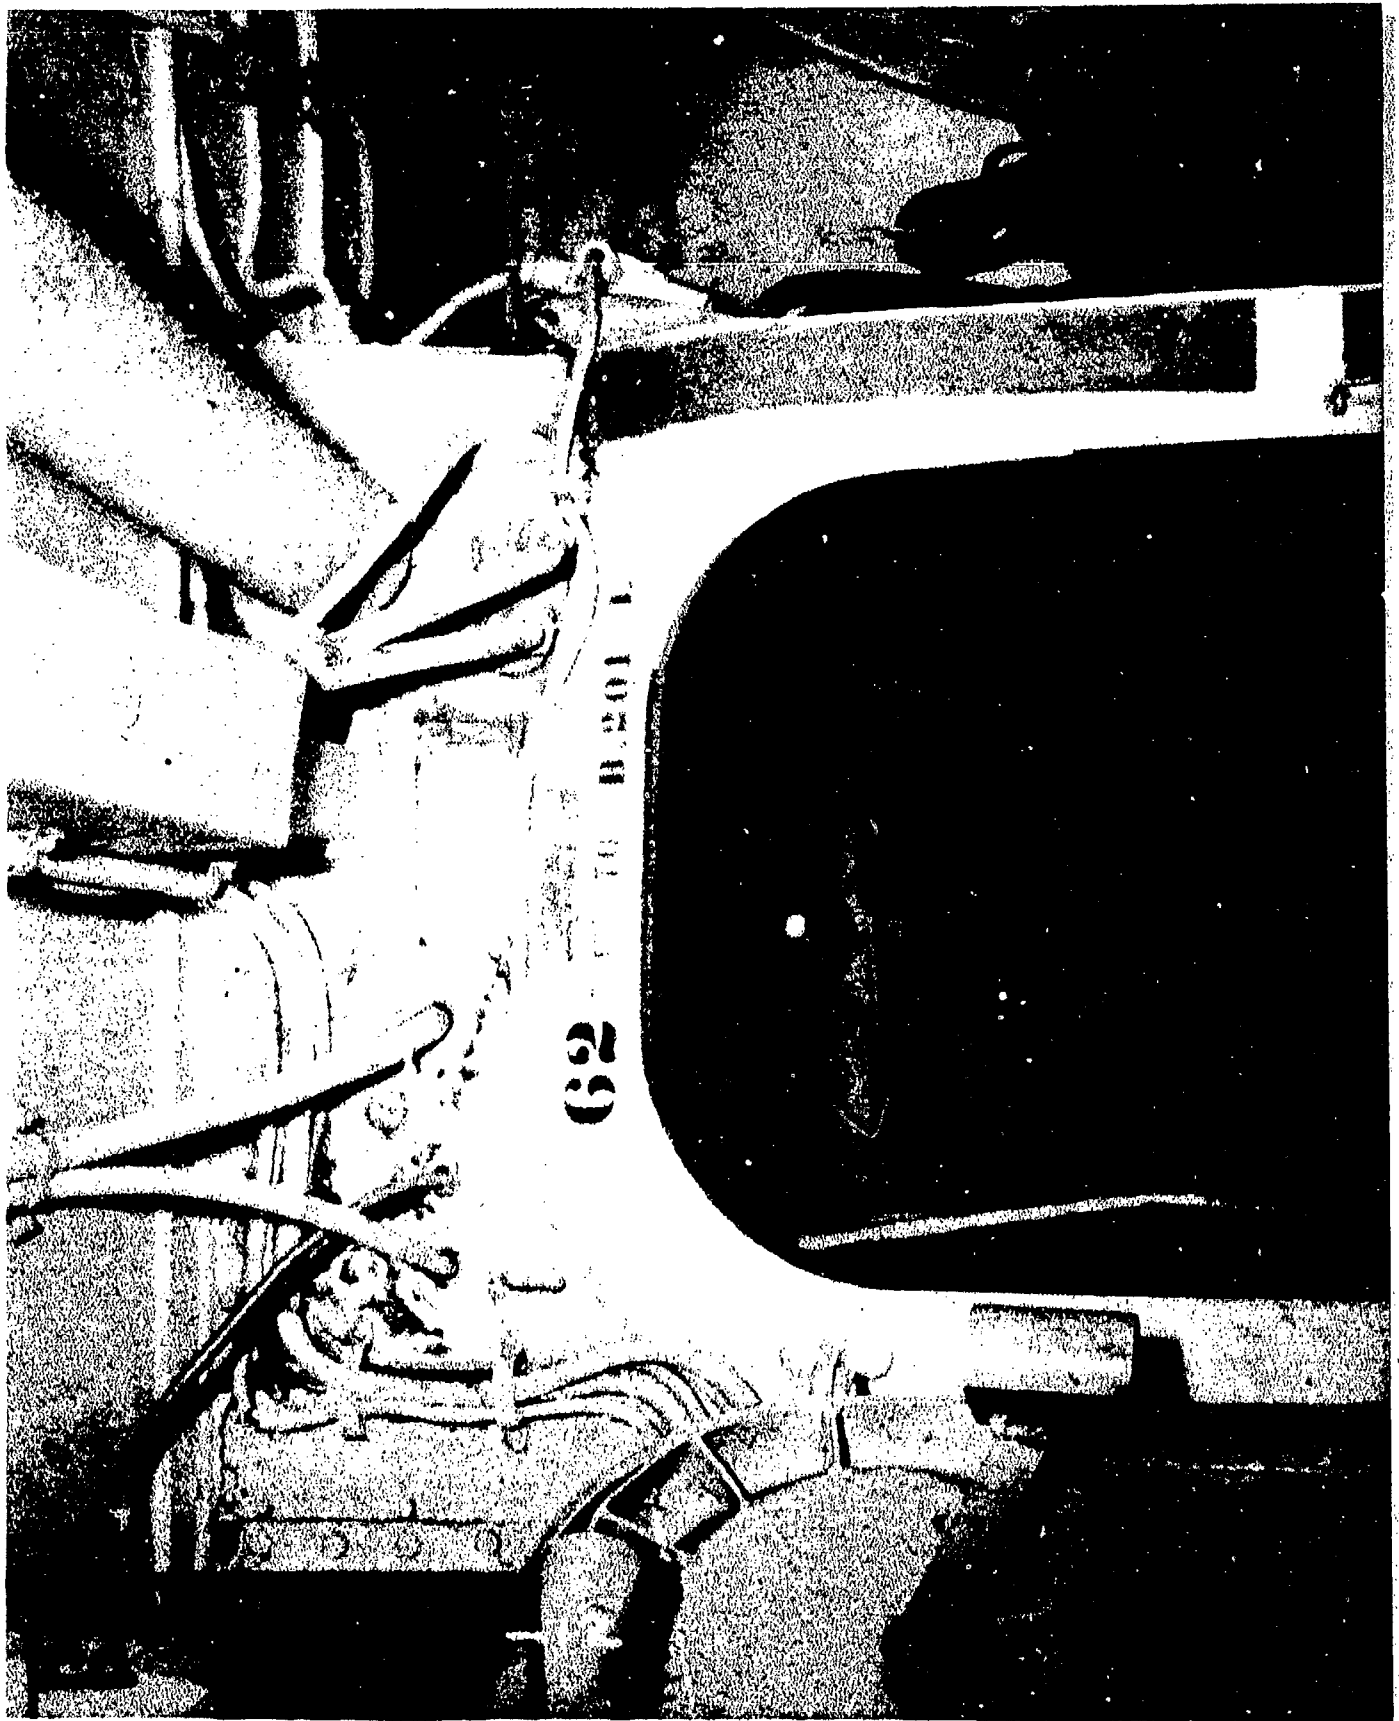
AA-CR-175-2157-12. C-201-L. Looking forward on 2nd deck through door in bulkhead 62 showing damage in port passageway B-201L caused by blast pressure in air intake area. Note crushing of bulkhead 62 near overhead as a result of deflection of the overhead.

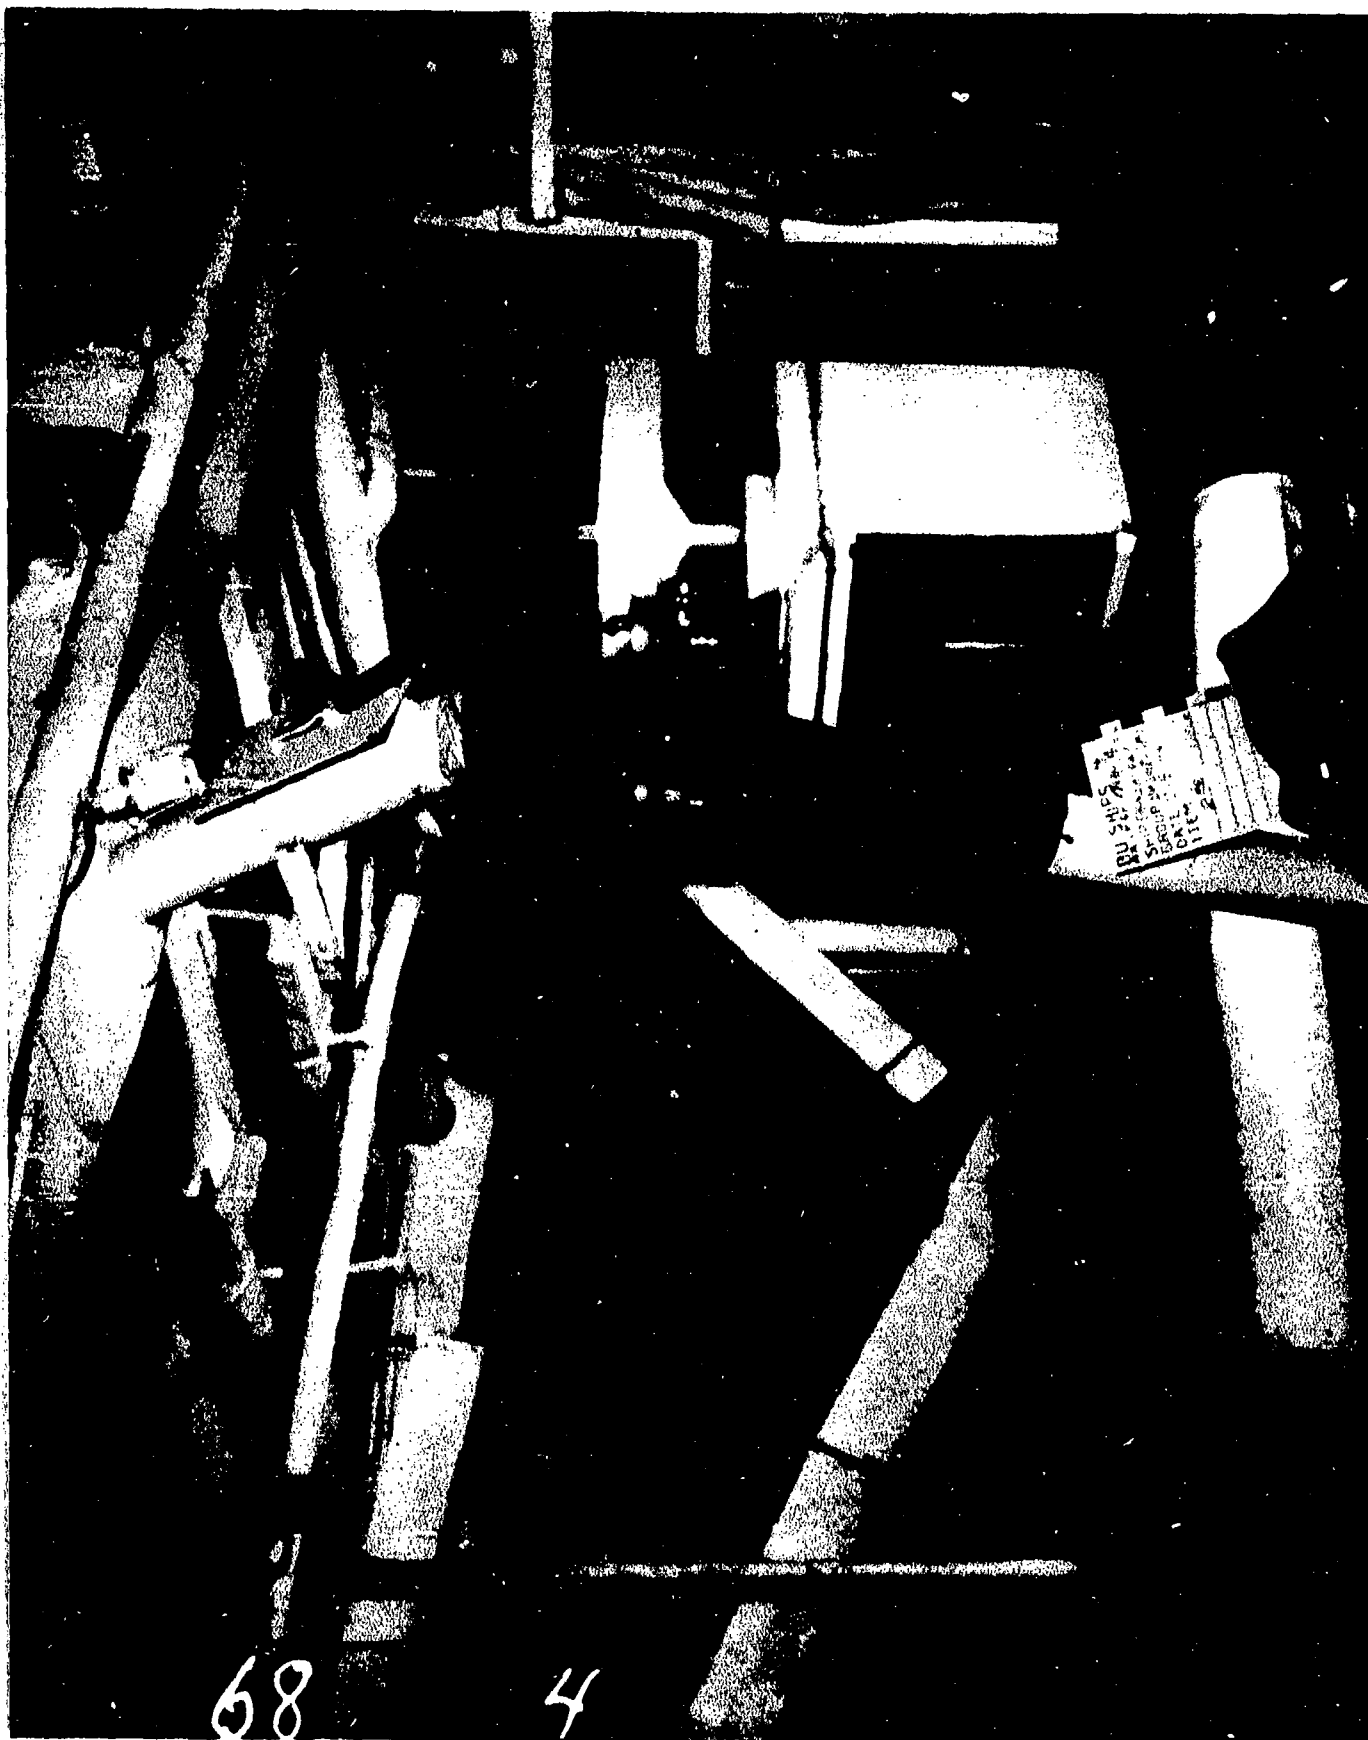
AA-CR-68-1768-4. C-201L. Looking forward and to starboard on 2nd deck in crew's space on port side showing buckled stanchion at frame 68 and damaged ventilation duct.

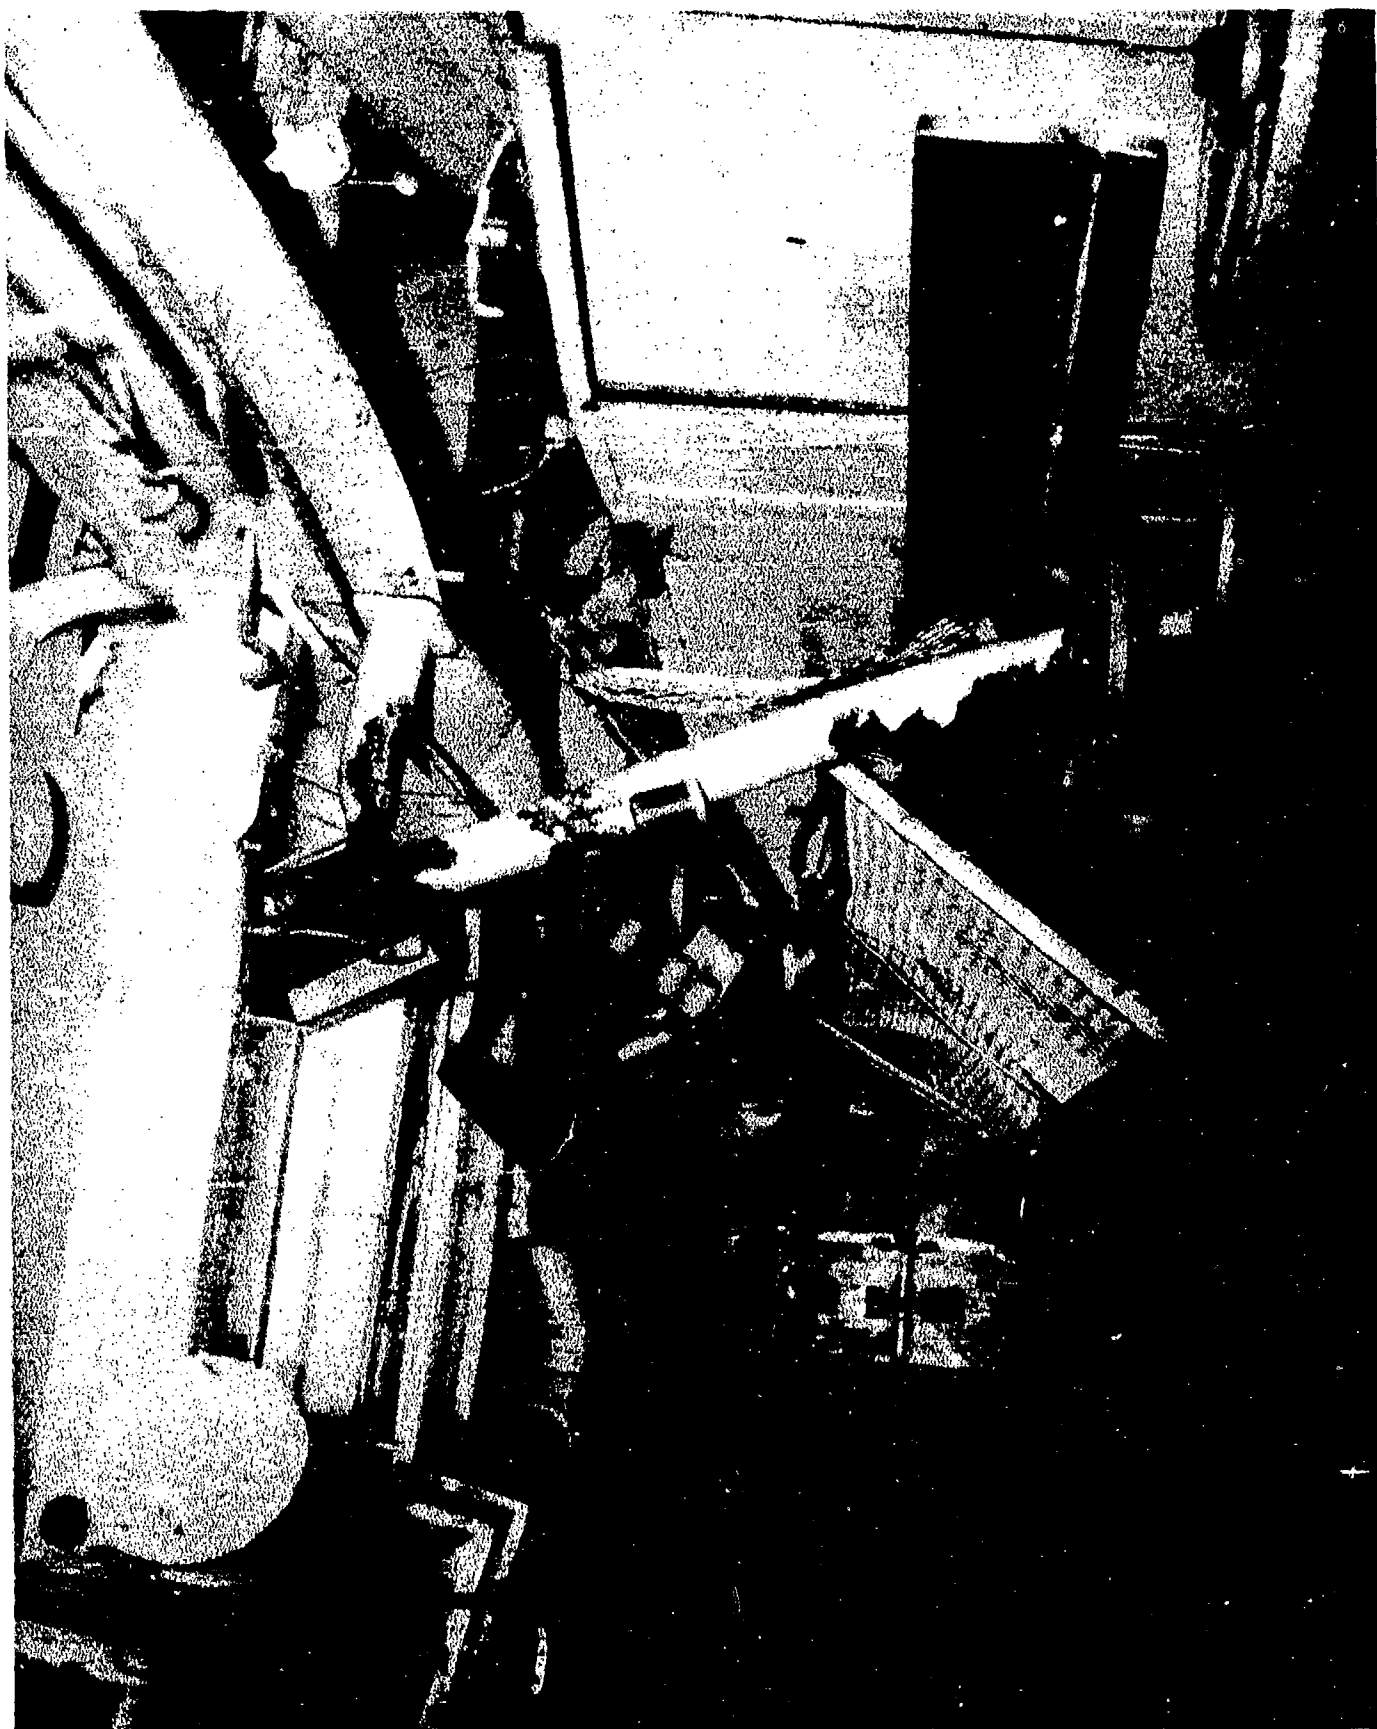
AA-CR-175-2158-1. C-201L. Looking to starboard on 2nd deck showing stanchion failures at web frame 65.

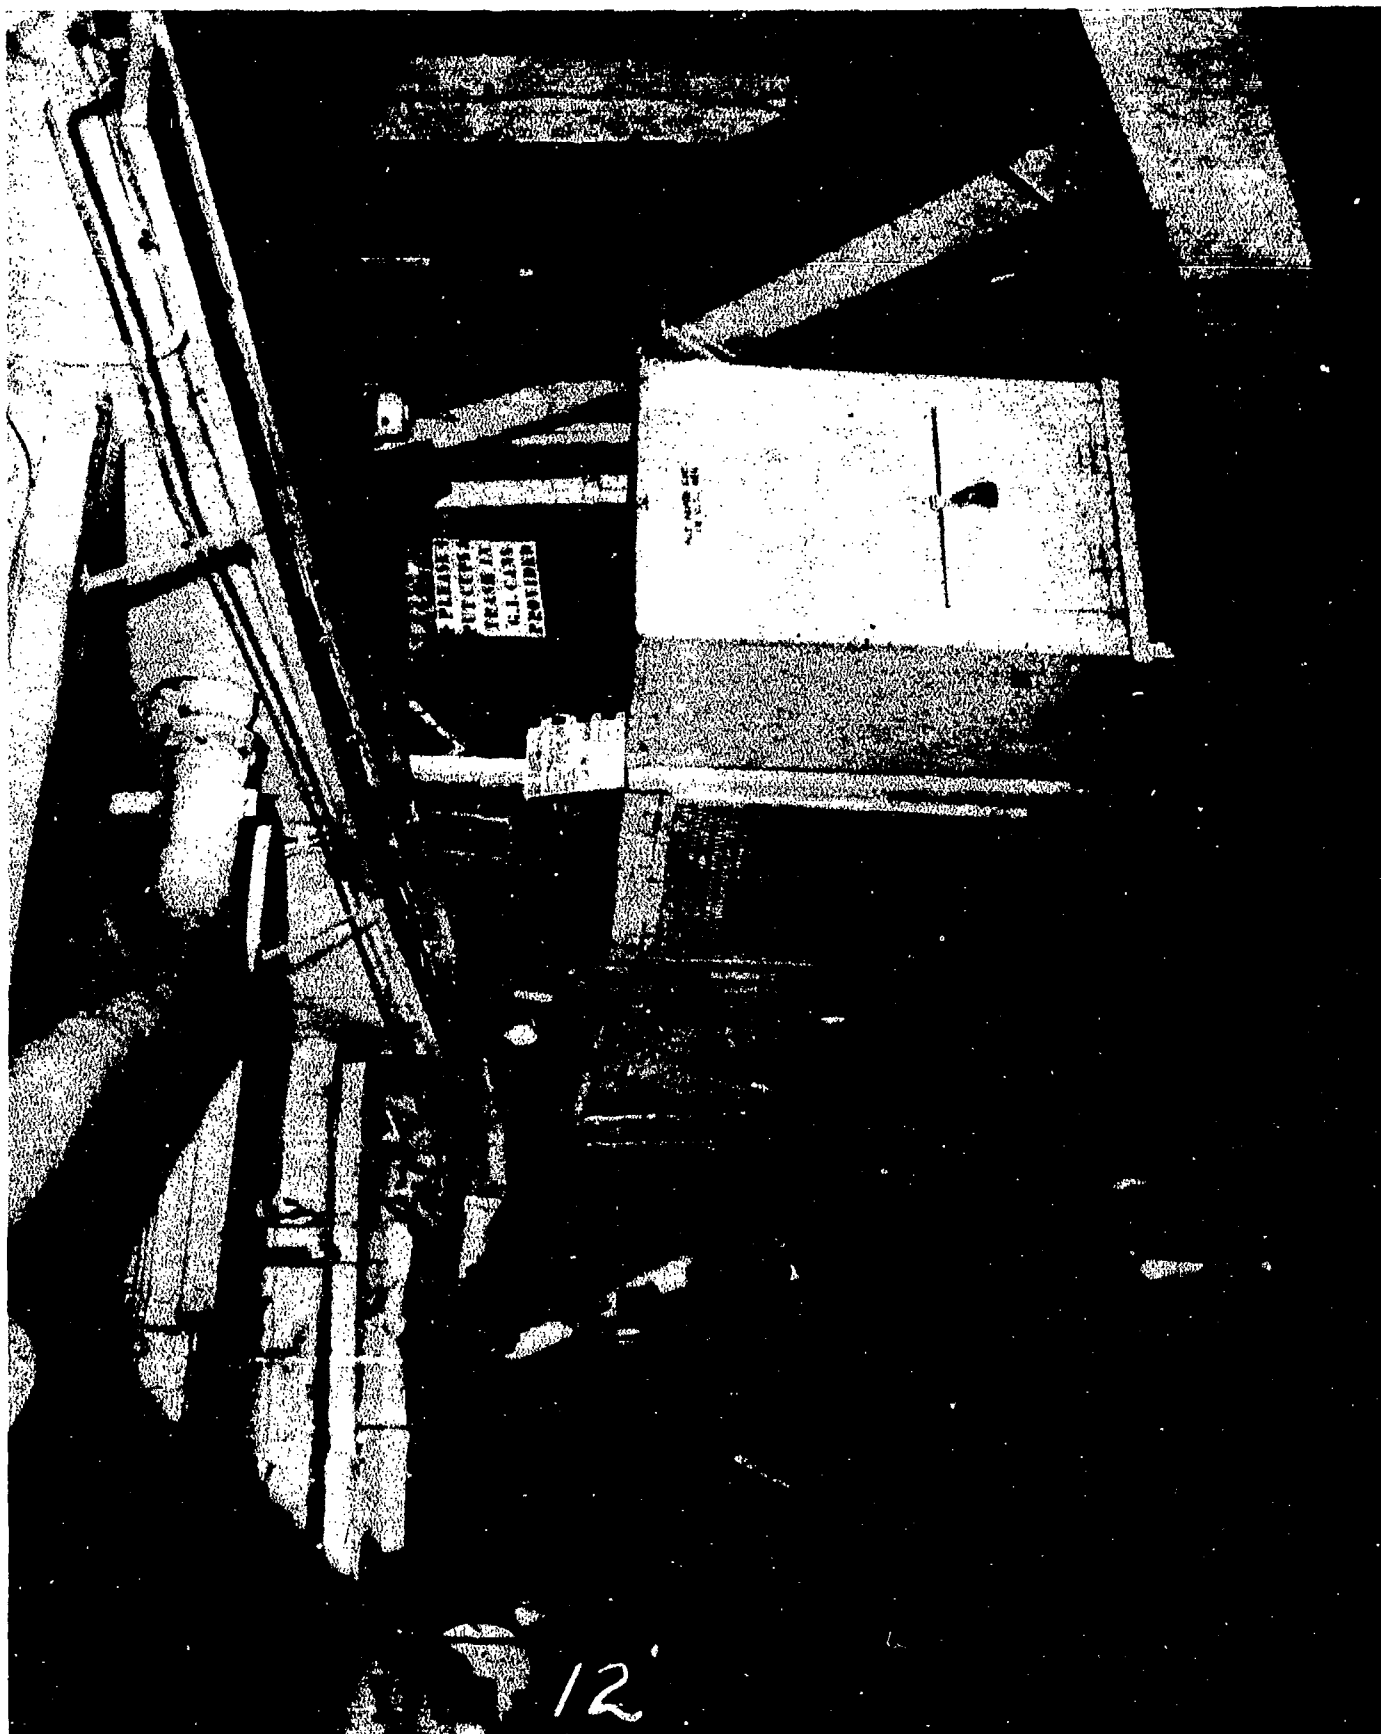
AA-CR-68-1767-12. C-201L Looking to starboard on 2nd deck along forward side of ship's service store showing stanchion failure at web frame 65.

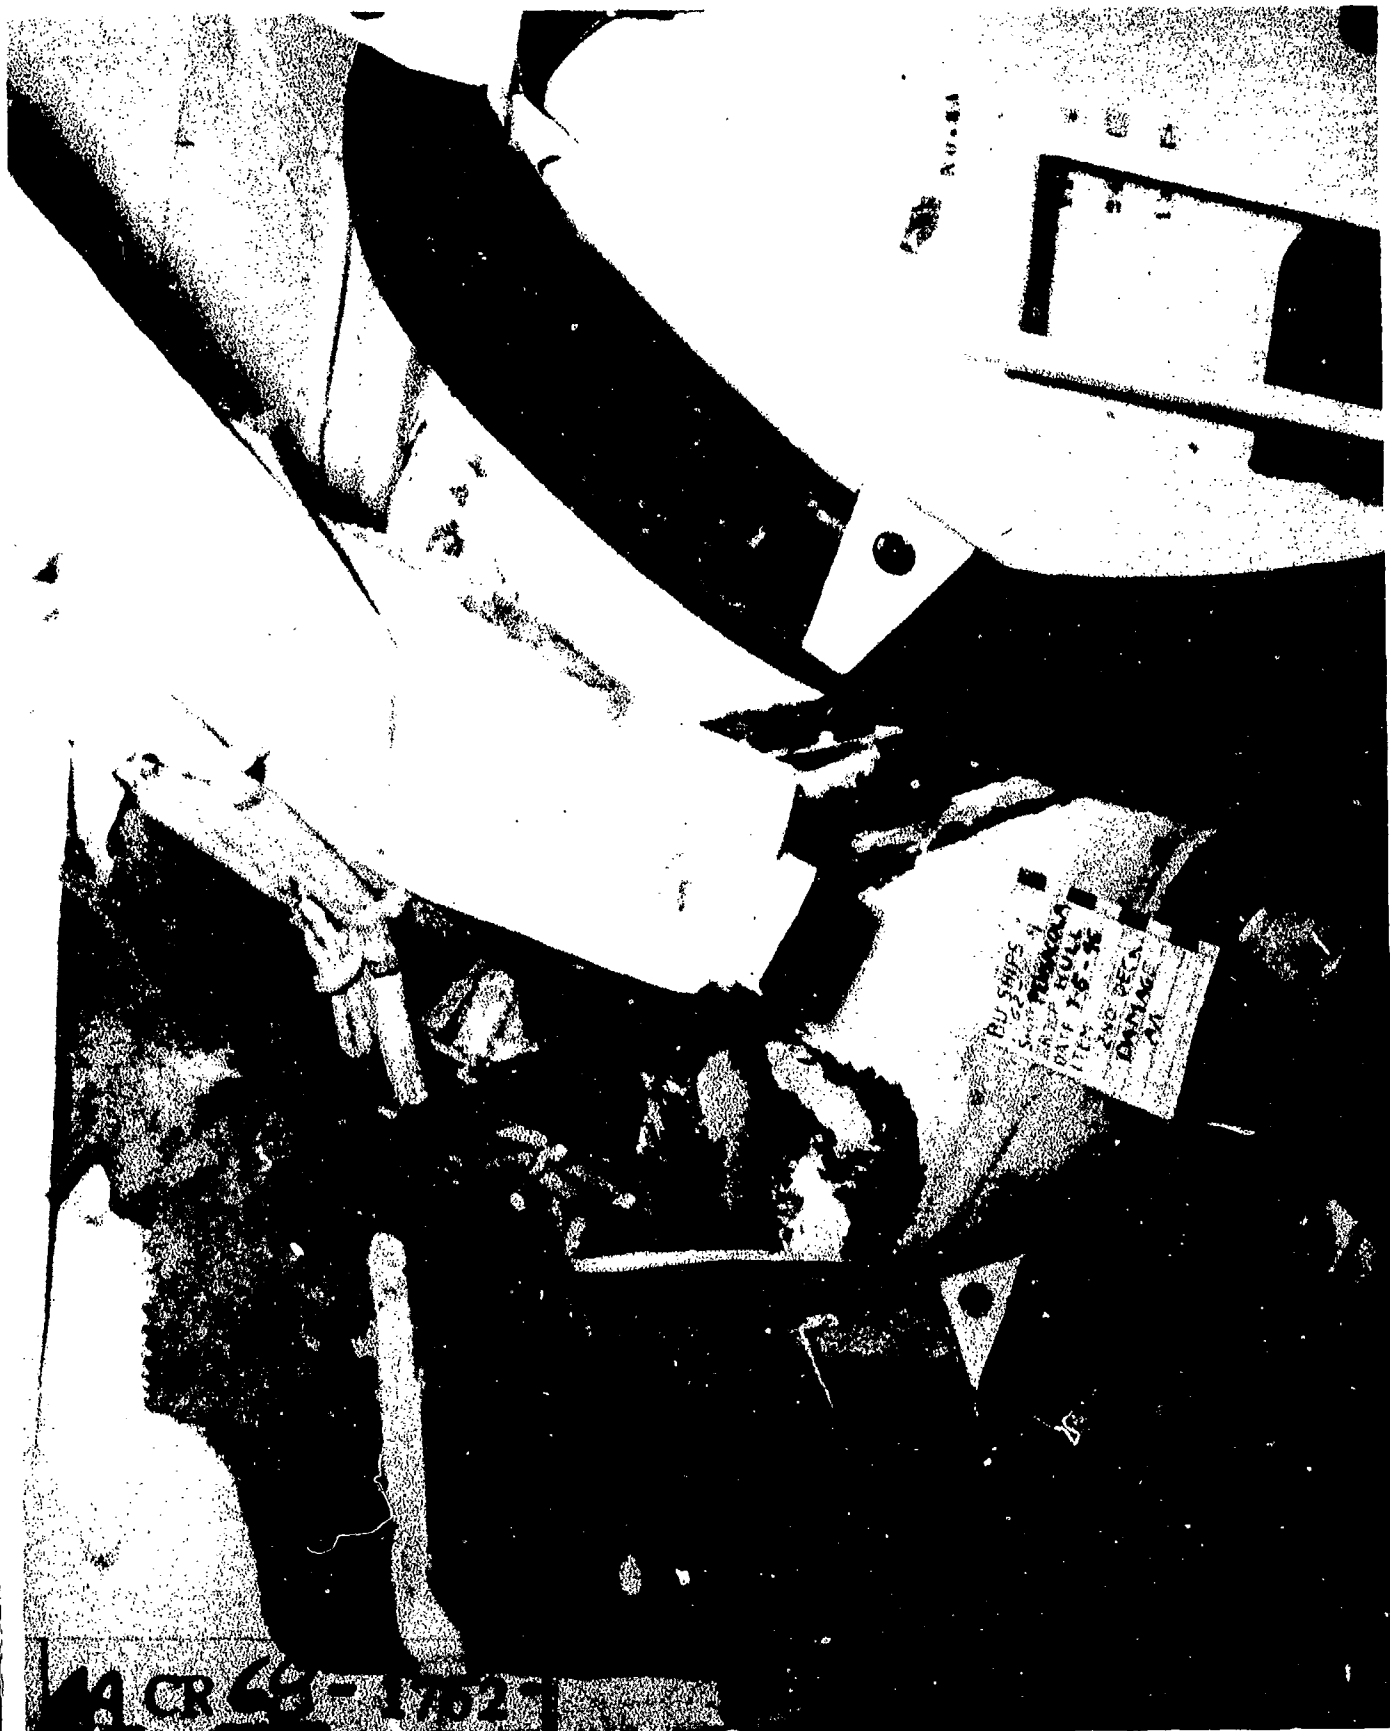
AA-CR-68-1762-9. Looking aft on 2nd deck along broken deck longitudinal located 8 feet to port of centerline. The forward port corner of the ship's service store appears in left background. The break in the longitudinal is approximately at frame 62.
